# **GeoRadar Division**

# GPR Solution for Bridge Deck Surveying

## RIS Hi-BrigHT SURVEY ON THE FORTH ROAD BRIDGE (1/9)

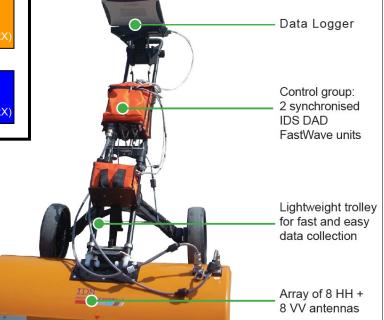
#### **RIS Hi-BrigHT Antenna architecture**

VV = polarization of the antenna modules

HH = polarization of the antenna modules

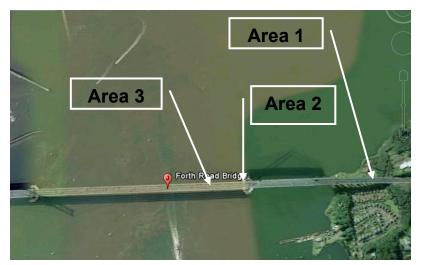
Areas investigated with Hi-Bright GPR

GPR survey on the Forth Road Bridge (United Kingdom) to evaluate:

- moisture deterioration in different areas of the bridge;
- deterioration expansion with the depth;
- detection of the different rebar layers.

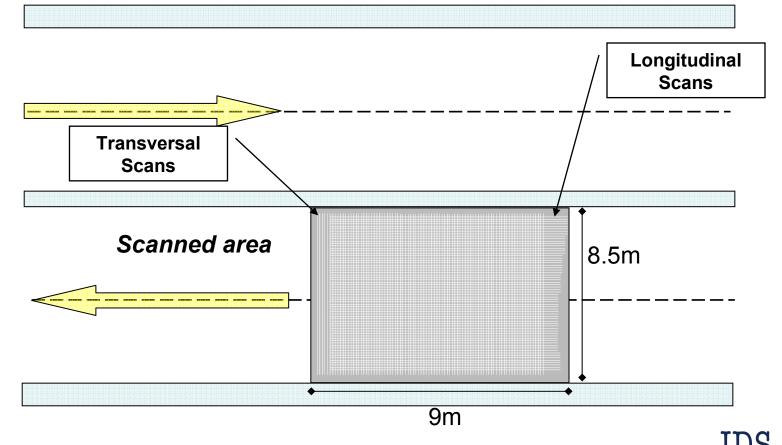
Test Area 1- Viaduct

Acquisition grid (Transversal and Longitudinal Scans)

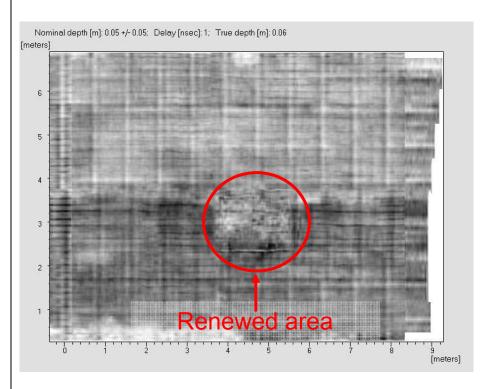
- monitoring of the expansion of the deteriorated area in the depth
- rebar detection

Rebar grid

Deteriorated area

Nominal depth [m]: 0.1 +/- 0.05; Delay [nsec]: 2; True depth [m]: 0.12

Horizontal cut at 5 cm from the asphalt

Horizontal cut at 10 cm from the asphalt

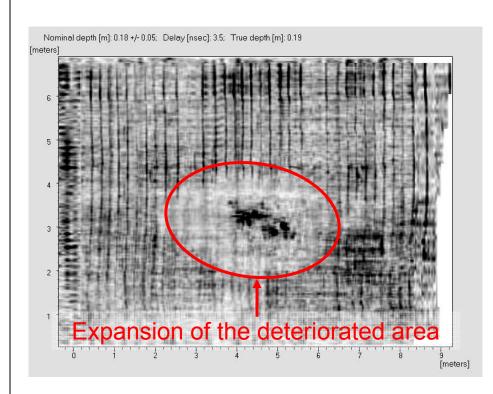
monitoring of the expansion of the deteriorated area in the depth

Horizontal cut at 18 cm from the asphalt

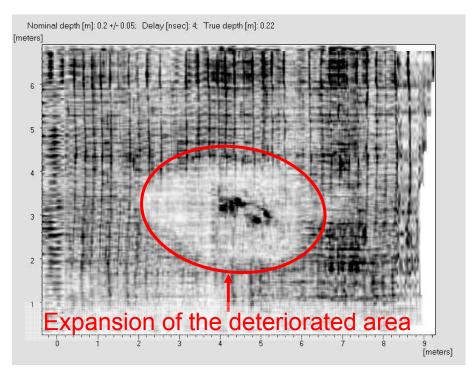
Horizontal cut at 20 cm from the asphalt

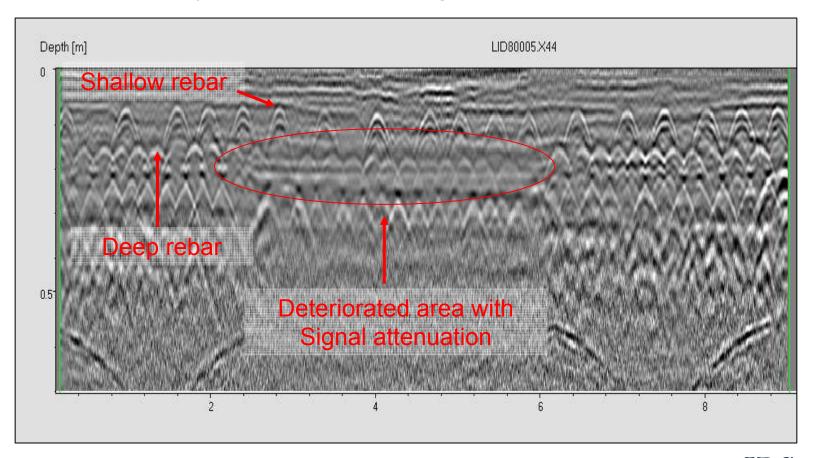
Different rebar layers detection on a longitudinal radar section

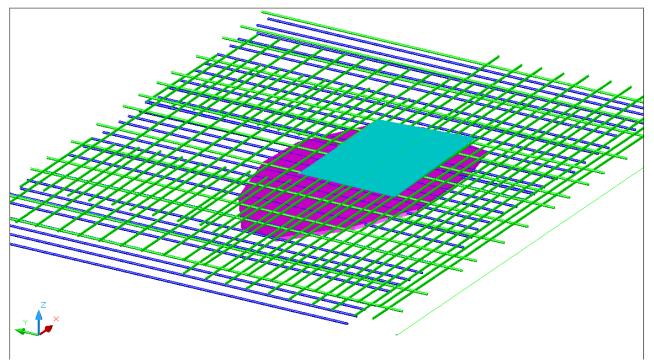
#### Test Area 1: 3D CAD with the detected structures and anomalies

- •shallow rebar (green)
- •deep rebar (blue)
- •renewed area (light blue)
- deteriorated volume (pink)

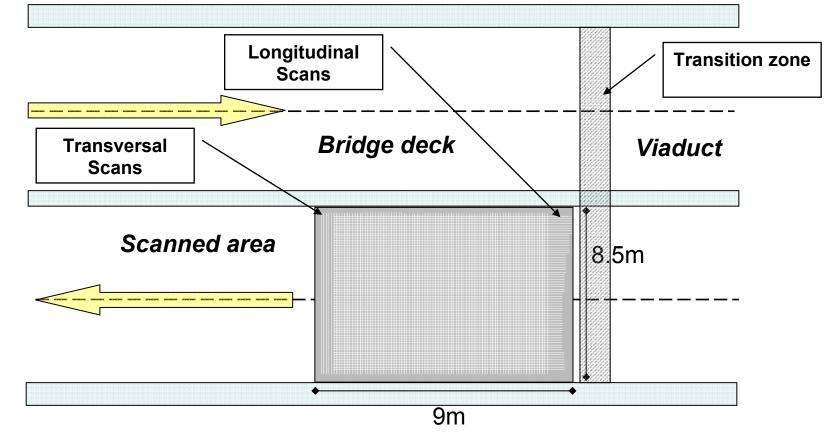
Test Area 2- Bridge deck
Acquisition grid
(Transversal and Longitudinal Scans)

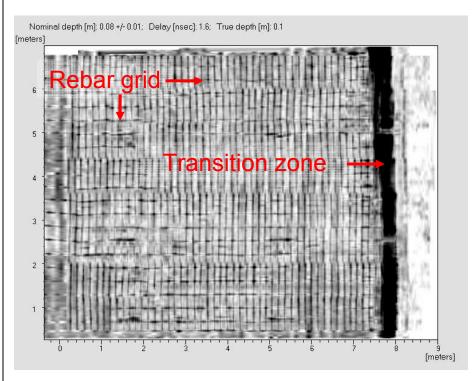
- detection of the transition zone (viaduct-bridge deck)
- rebar detection
- beams detection

Horizontal cut at 8cm from the asphalt

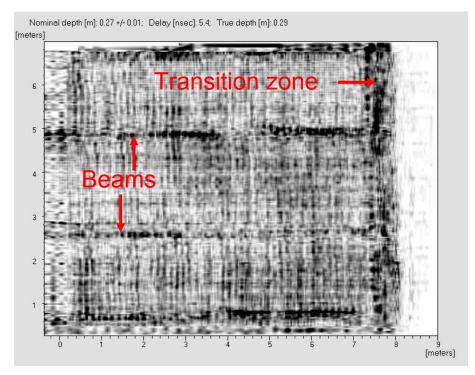
Horizontal cut at 27 cm from the asphalt

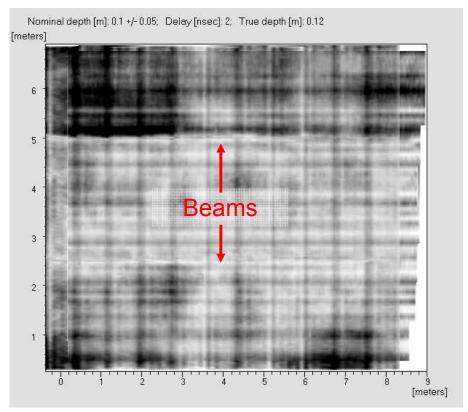
#### Results on test Area 3 - Bridge deck:

beams detection

Horizontal cut at 10 cm from the asphalt
