The Neustadt Bayernoil refinery

A FLIR INFRARED FURNACE CAMERA FOR HIGH TEMP INDUSTRIAL APPLICATIONS WATCHES HYDRO REFORMERS AT GERMAN BAYERNOIL REFINERY COMPLEX

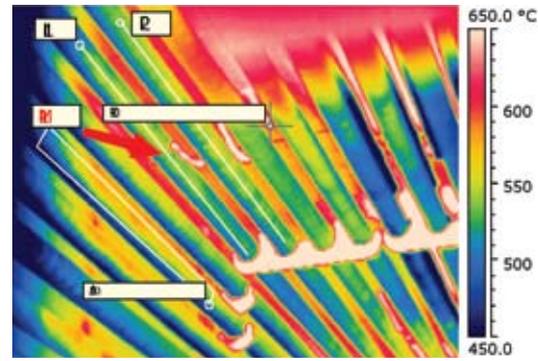
Light temp deviation along ceiling probably due to deposits inside the piping

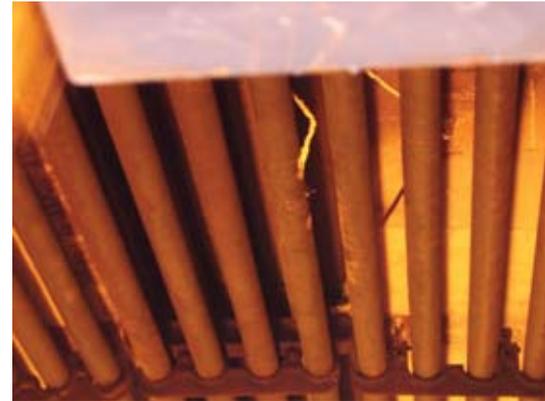
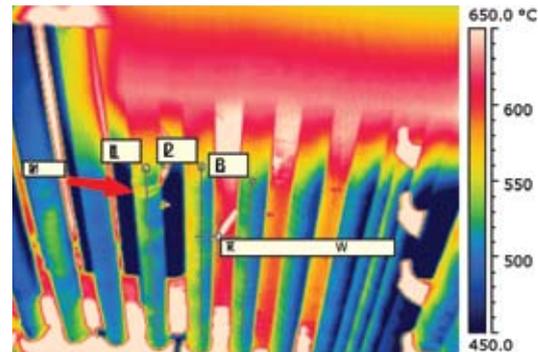
Visual and IR image of inner furnace piping: Mk2 shows a temp sensor fastener, not a hot spot cab le
